INDEX 1965 - 1966

TECHNICAL SERVICE BULLETINS

SECTION D

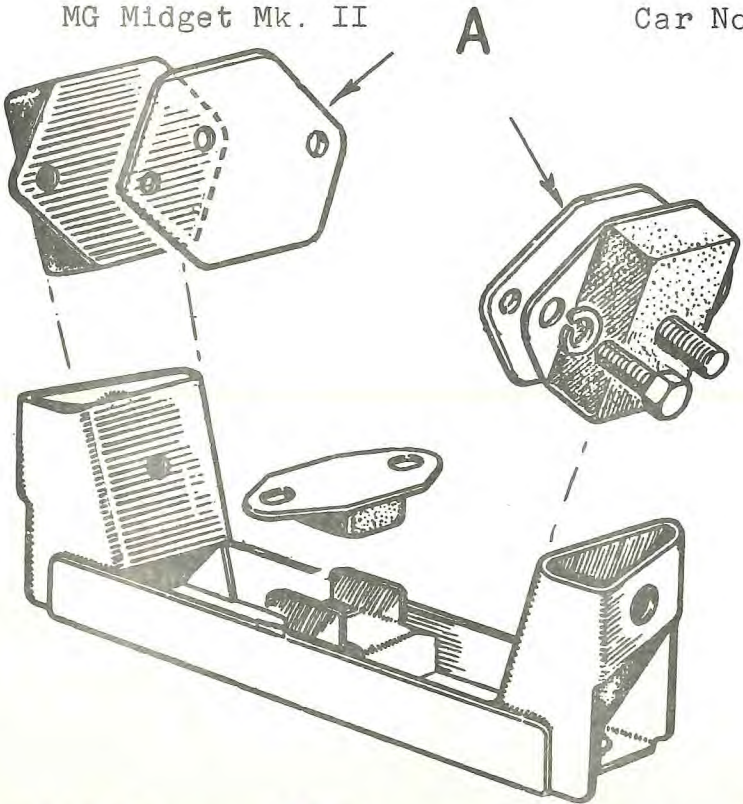
Certain complaints of engine vibration and harshness have been traced to the gearbox rear extension resting on the rear mounting support.

This condition may be rectified by inserting packing pieces, Part No. 2A 5423, between the mounting assembly and the gearbox rear extension, as incorporated in production from the following change-points:
