INDEX 1965 - 1966

TECHNICAL SERVICE BULLETINS

TECHNICAL SERVICE BULLETIN

The British Motor Corporation / Hambro Inc.

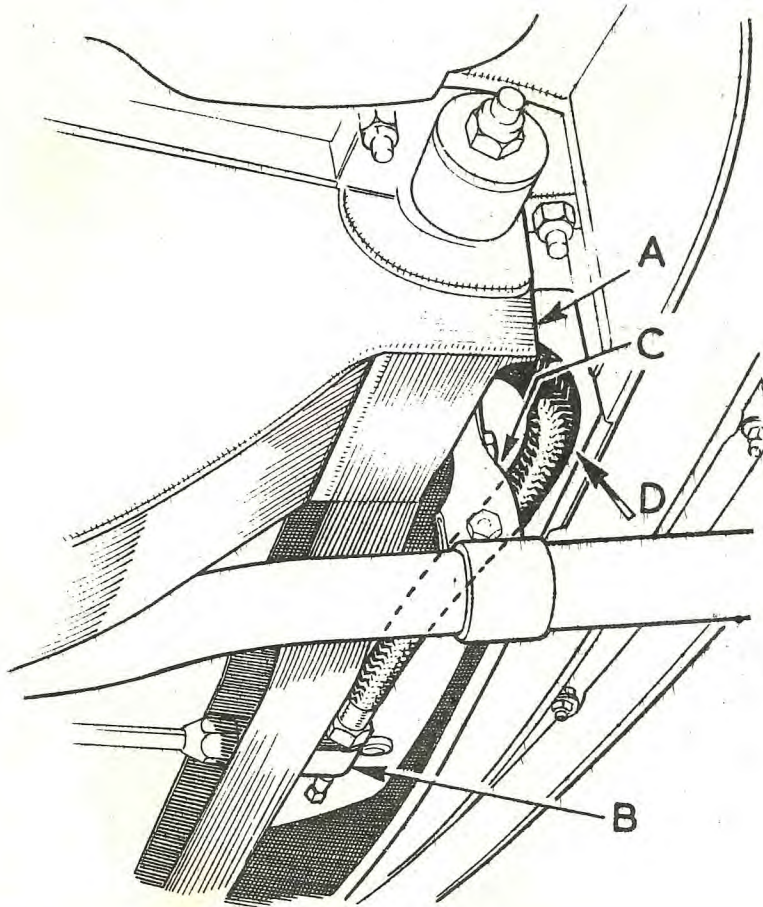
When fitting a new displacer unit the hose must be assembled to take a straight natural path, on a line between the hole in the rear sub-frame sleeve 'A' and elbow 'B'. This can be achieved by holding the hose initially with a slightly reversed bias, which will untwist into line on final tightening. Failure to observe this procedure will probably result in the hose fouling the rear exhaust pipe bracket 'C' and the lower edge of the body rear panel 'D'.

NB. Before pressurizing the system, the flexible hose may appear to be stretched and to be close to the exhaust mounting. This condition will rectify itself when the system is pressurized as the hose will protrude from sub-frame approximately a further inch, thus giving adequate clearance between hose and exhaust mount.

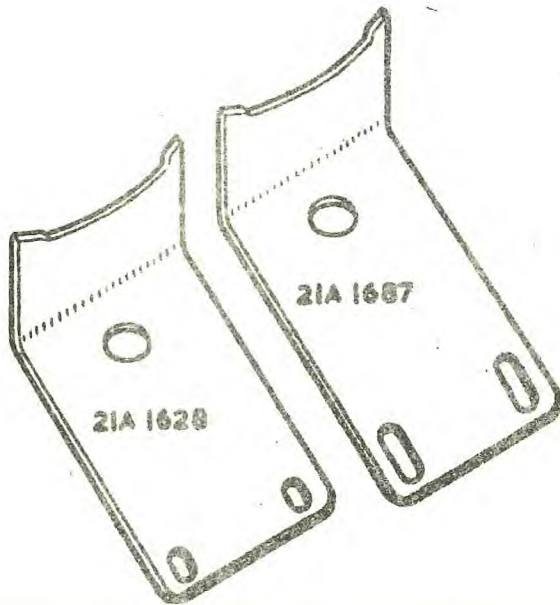
In order to accommodate minor variations in the shape of the Hydrolastic unit, the locating slots 'A' in the stop bracket 21A 1628 have been re-positioned and lengthened.

When supplying a new displacer unit prior to the above change points the new stop bracket 21A 1687 is also required to avoid difficulty in fitting the displacer. 21A 1687 should be assembled with flat washers PWZ 203.
